Manhole Inspection Summary

Manhole # S35AA_031MH

Insp Date: **5/27/09 2:24 PM**

Location Address: **107 READ ST**

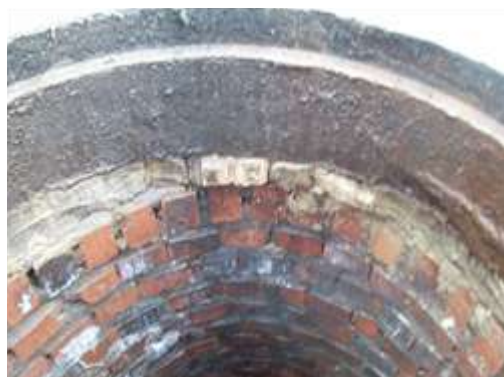
Defect 4

Condition: ☐ Sound ☐ Cracked ☒ Root Intrusion ☒ Loose Brick ☒ Deteriorated

LOOSE BRICKS IN CHIMNEY and root intrusion

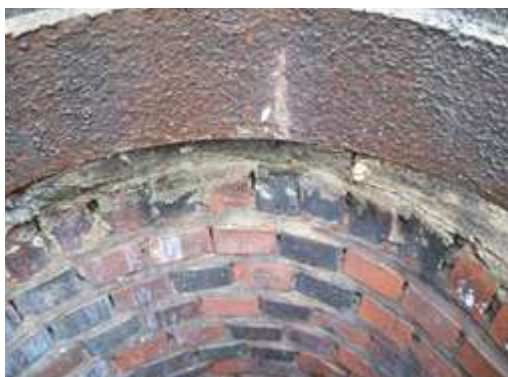
Defect 3

Infiltration: ☐ None ☐ Joint ☐ Cracks ☒ Mortar ☐ Roots ☐ Wall

infiltration at mortar

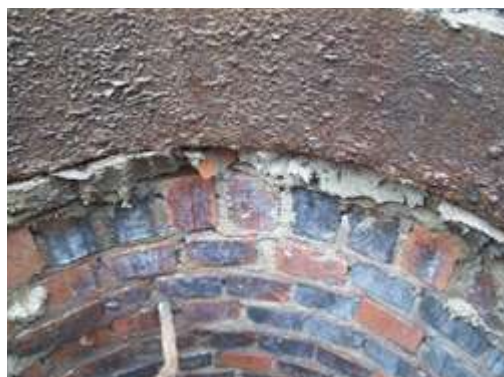
Defect 2

deteriorated chimney

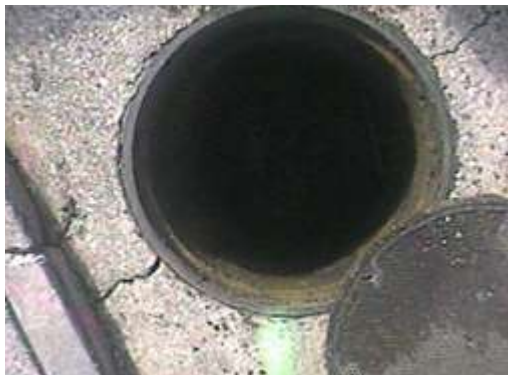
Defect 1

Frame Offset: **2** (in.) Condition: ☒ Sound ☐ Cracked ☐ Leaks

FRAME OFFSET

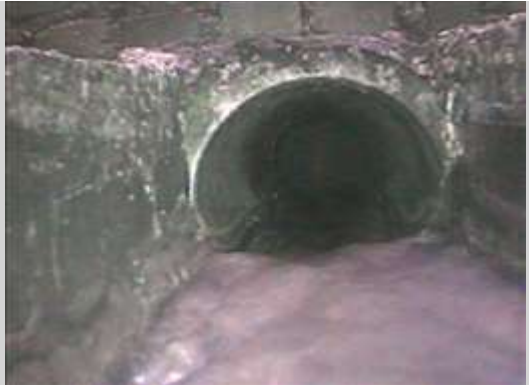
12 O'Clock Outflow

8 in. Circular Gravity Sewer
Pipe Out @ 12 O'Clock

Invert Depth: **8.28** (ft.) Flow Characteristics: **Slow**

Infiltration: **None** Pipe Seal Cond: **Sound**

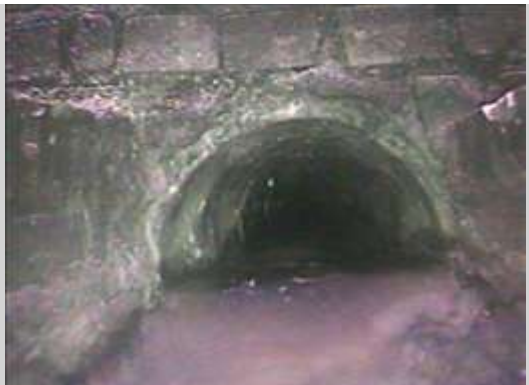
6 O'Clock Inflow

8 in. Circular Gravity Sewer
Pipe In @ 6 O'Clock

Invert Depth: **8.37** (ft.) Flow Characteristics: **Slow**

Infiltration: **None** Pipe Seal Cond: **Sound**
